# Lorinna Road Upgrade Assessment

Prepared for: Kentish Council

Date: December 2013  
Rev 03

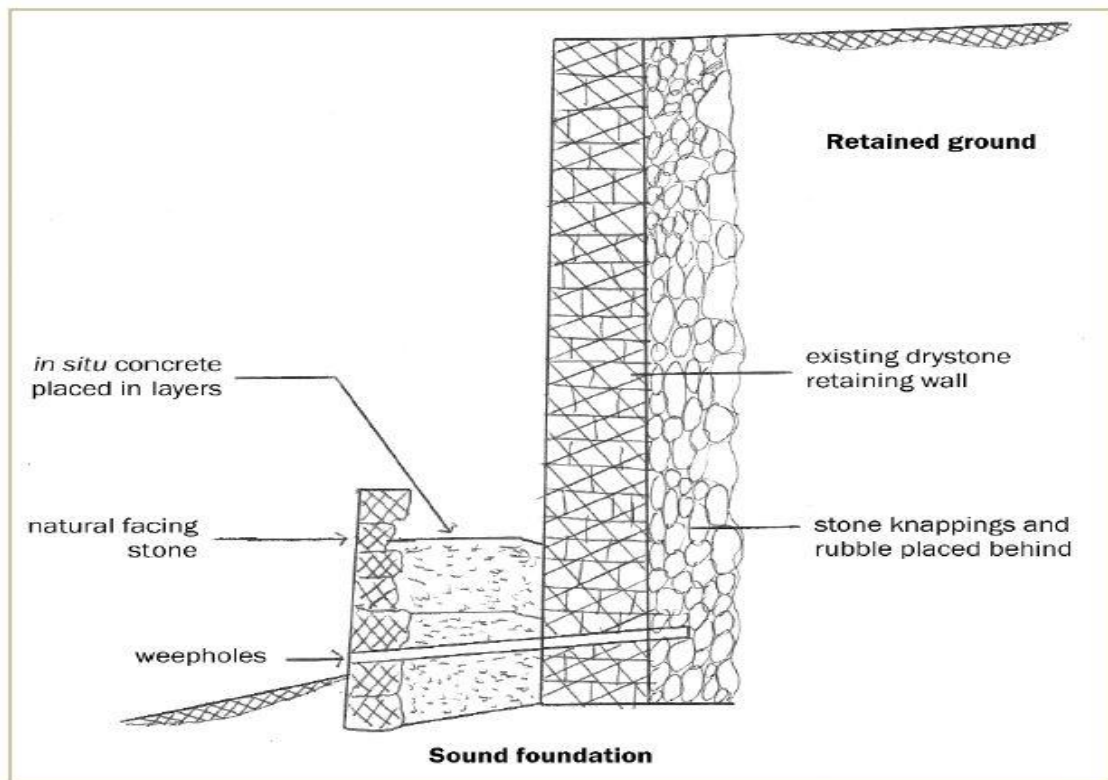
Figure 1

***Cross-section of construction of thickening to an existing drystone retaining wall***

Critical to thickening of the wall would be ensuring an adequate founding as well as achieving a sufficient bond with the original wall. This is usually achieved with mass concrete and drainage pipes in it to manage water.

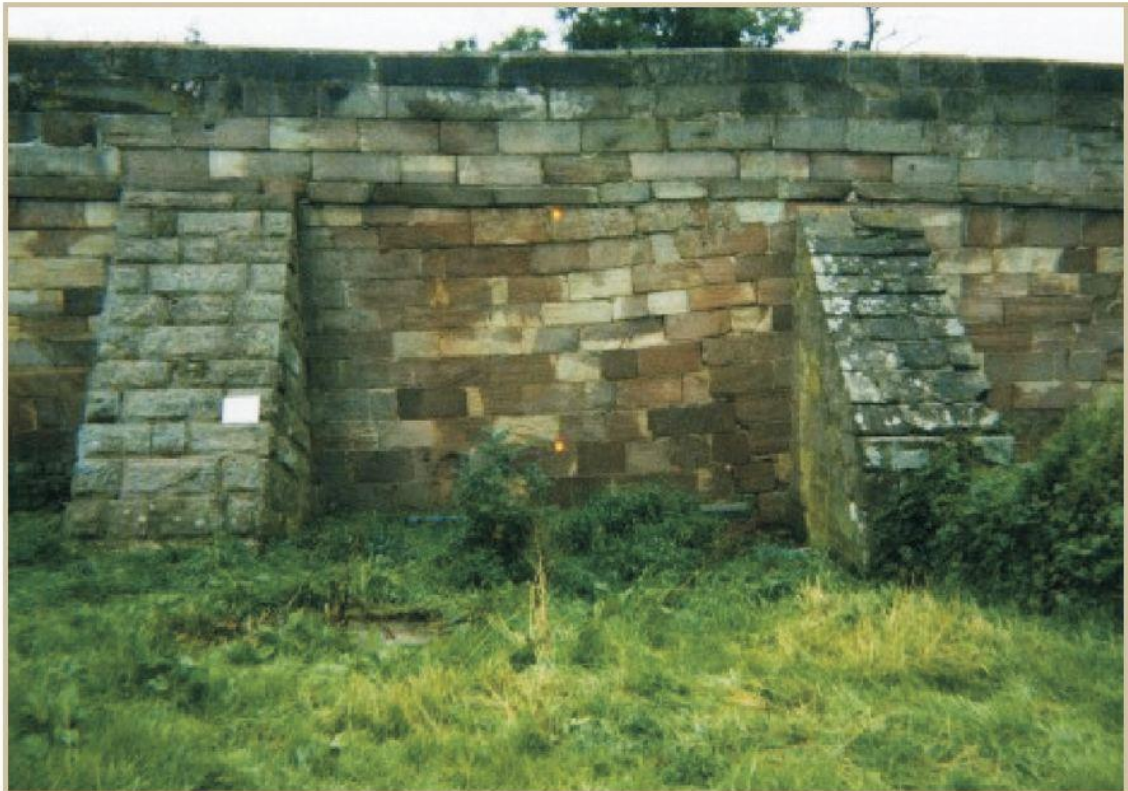
Figure 2

An example of buttressing of a dry stone wall is shown in Figure 2.

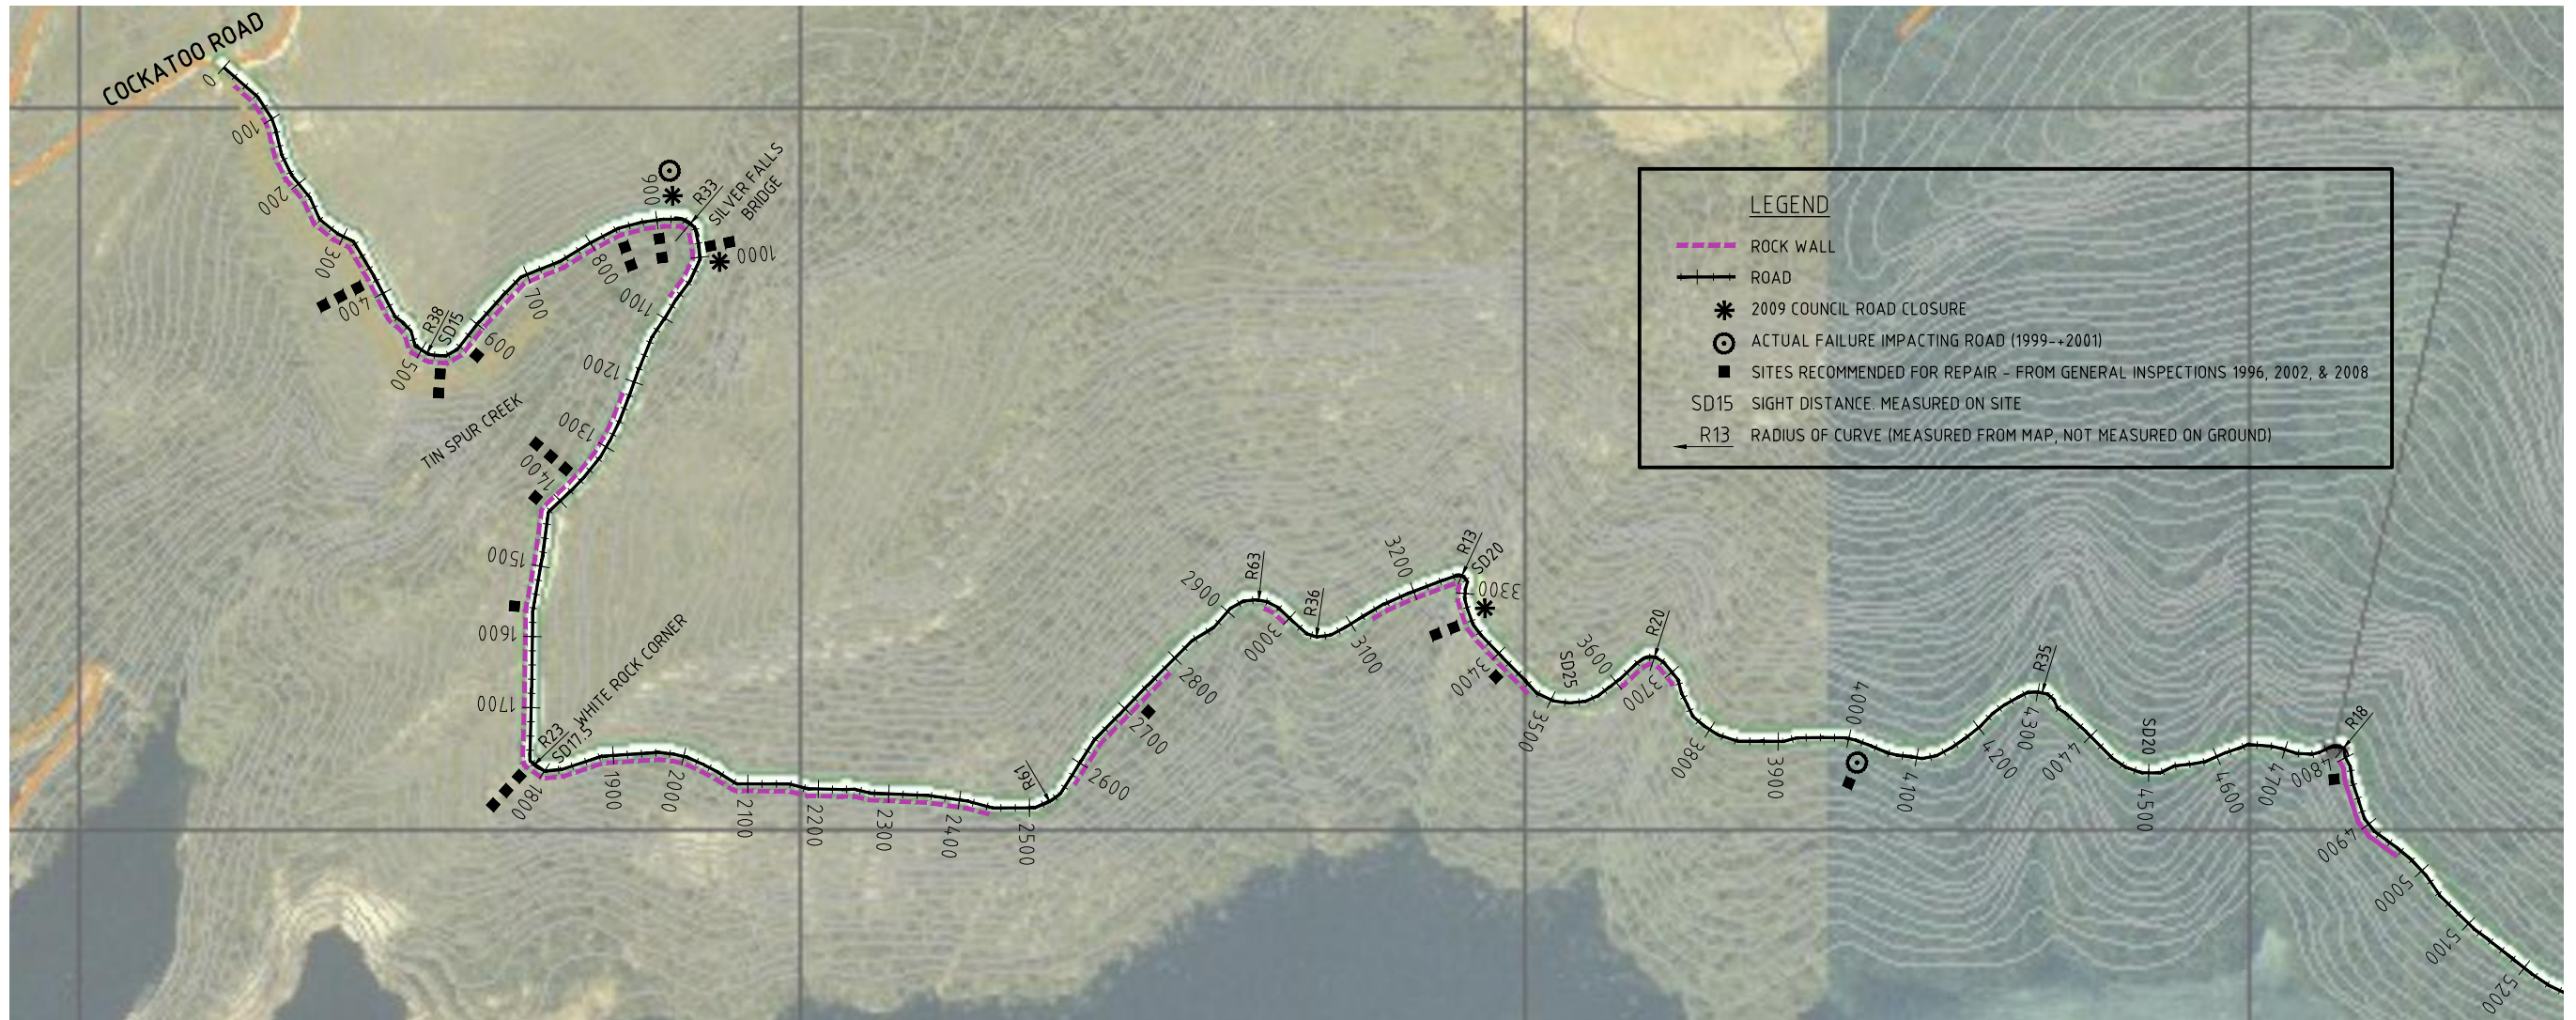
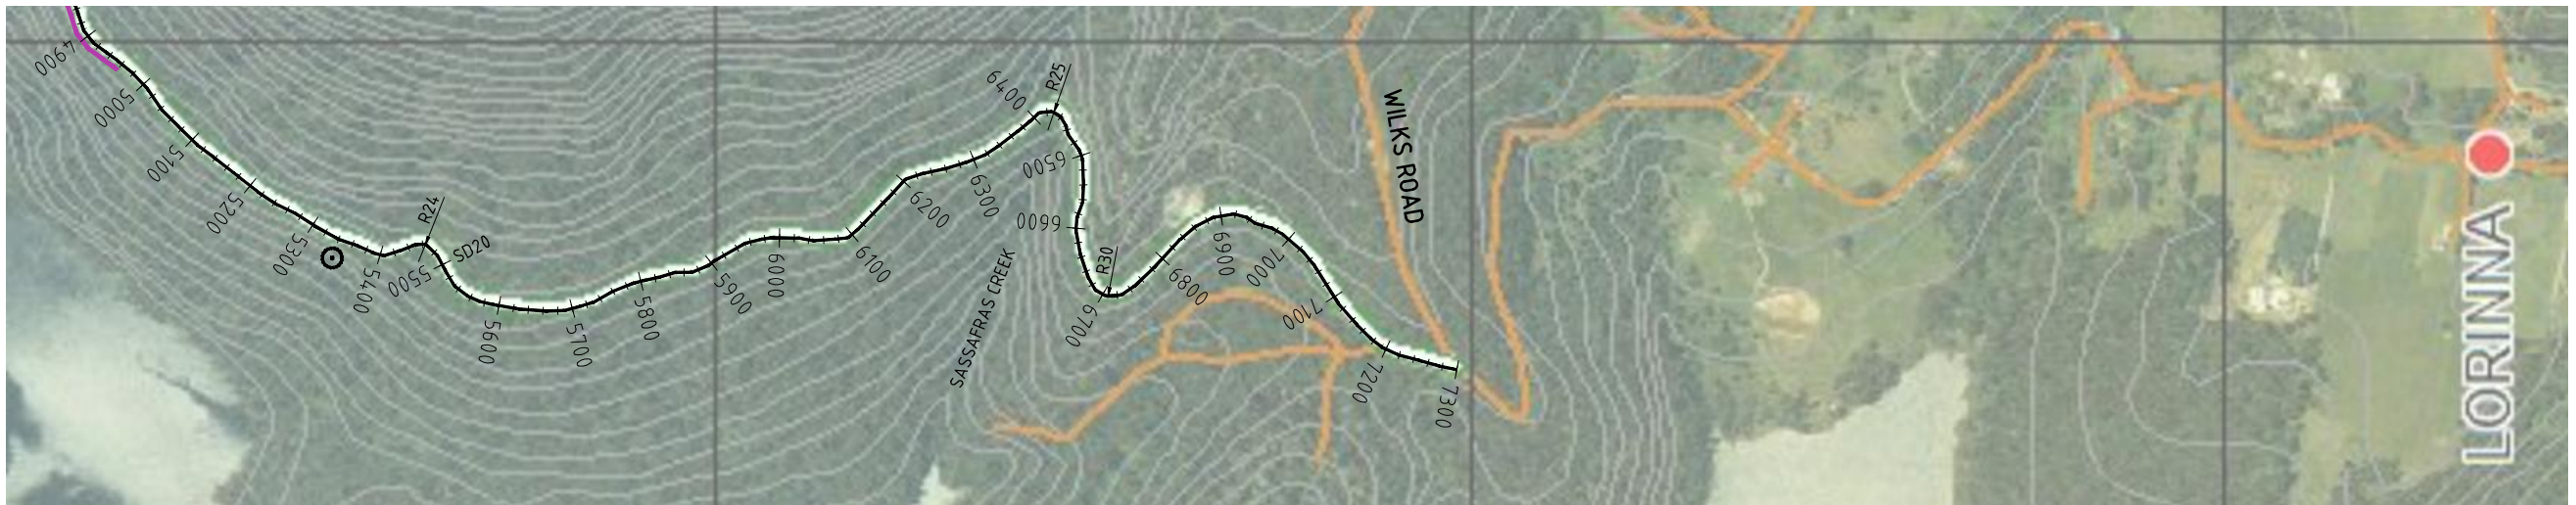
DRAWING No. **HB12097-P1** REVISION

- Distance along the road
- The areas where road widening is required
- Rock wall repair sites with priority
- Existing passing bays and additional passing bays required.
- Location of possible safety barrier

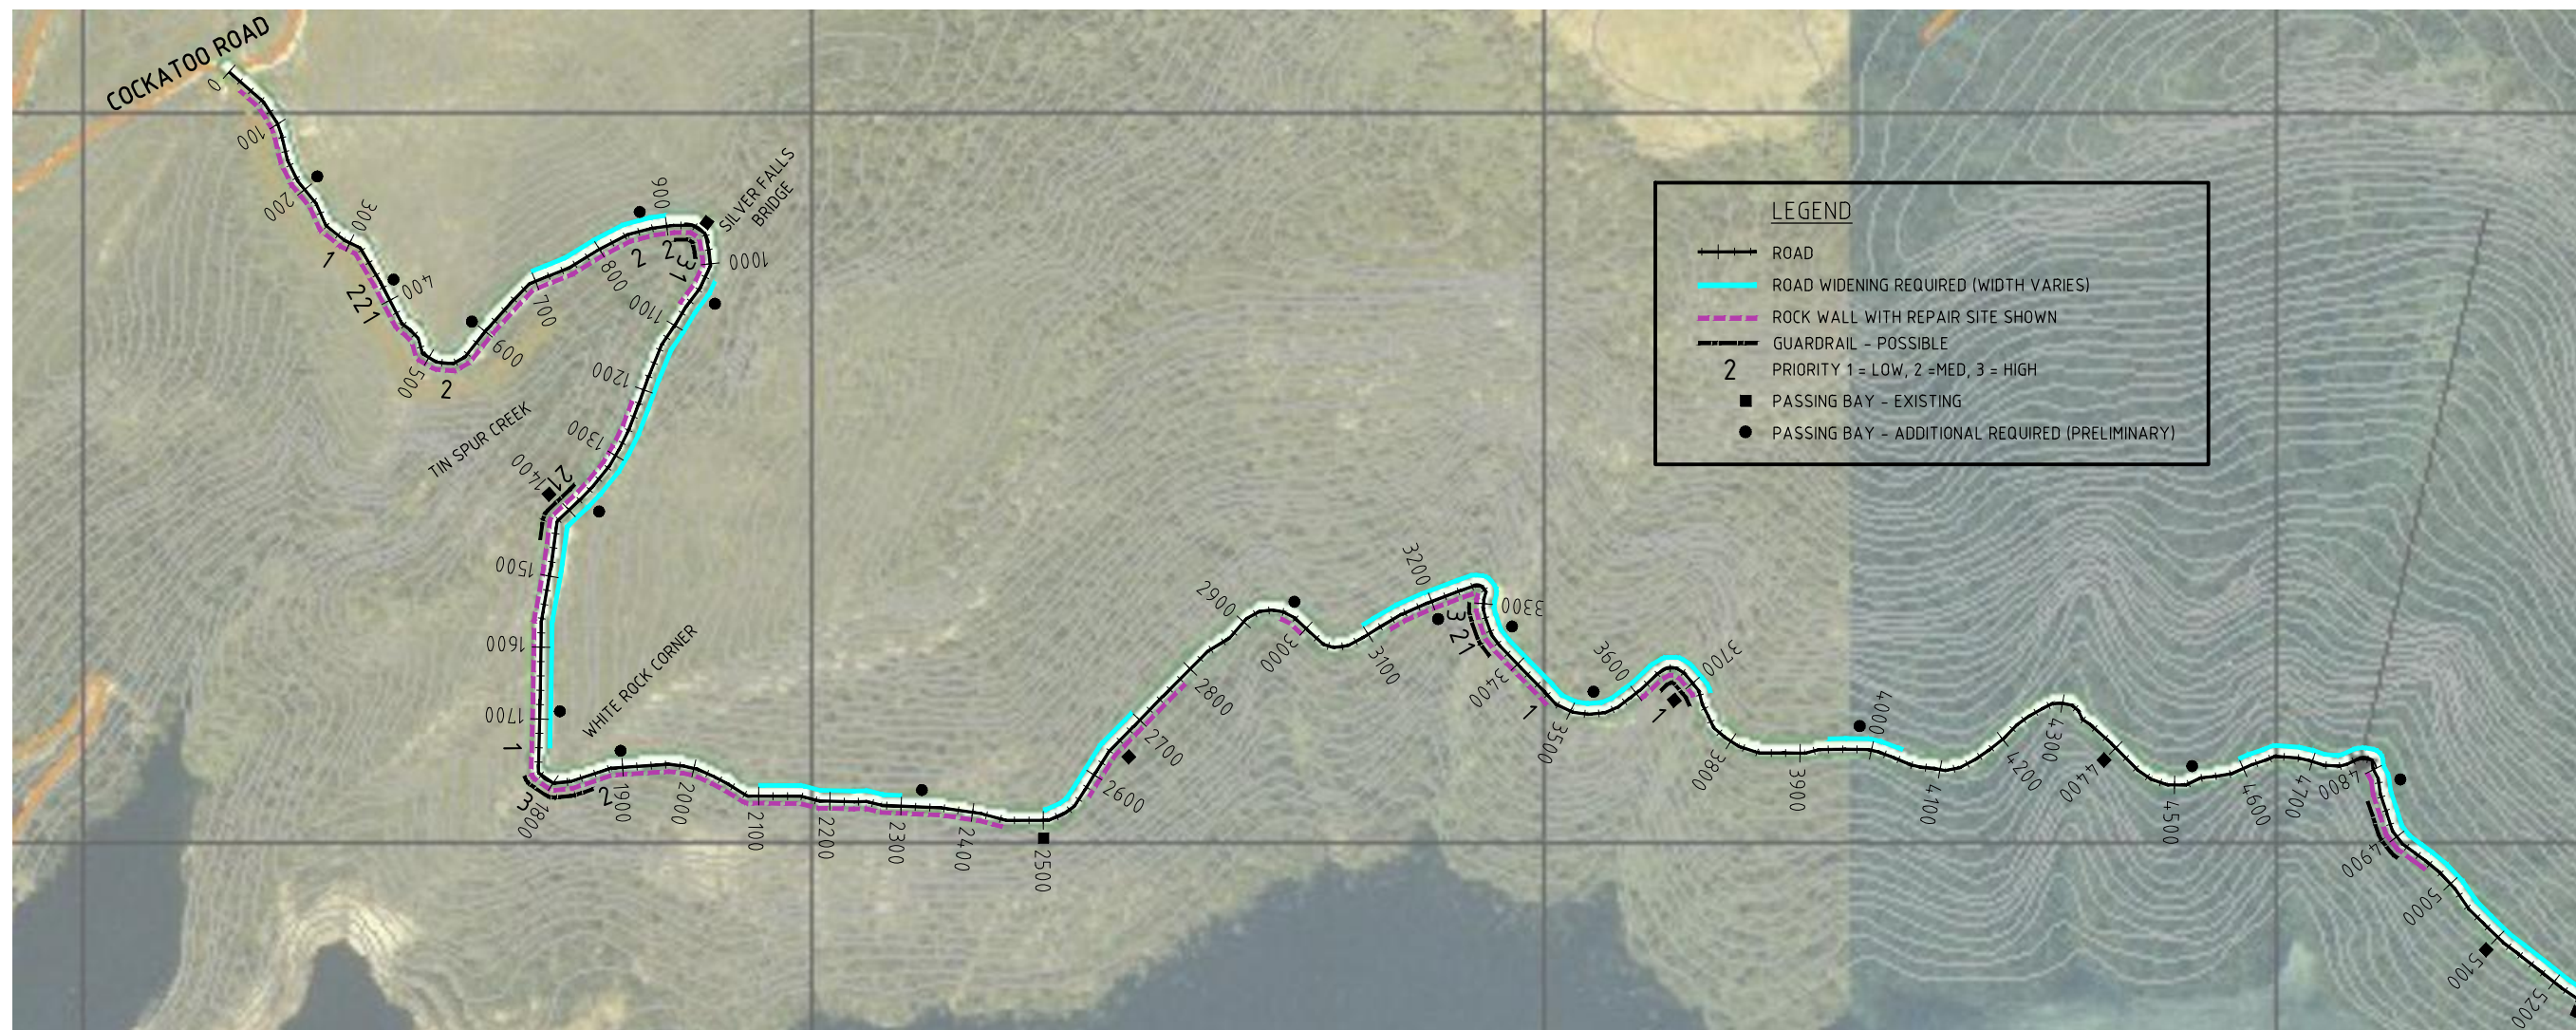
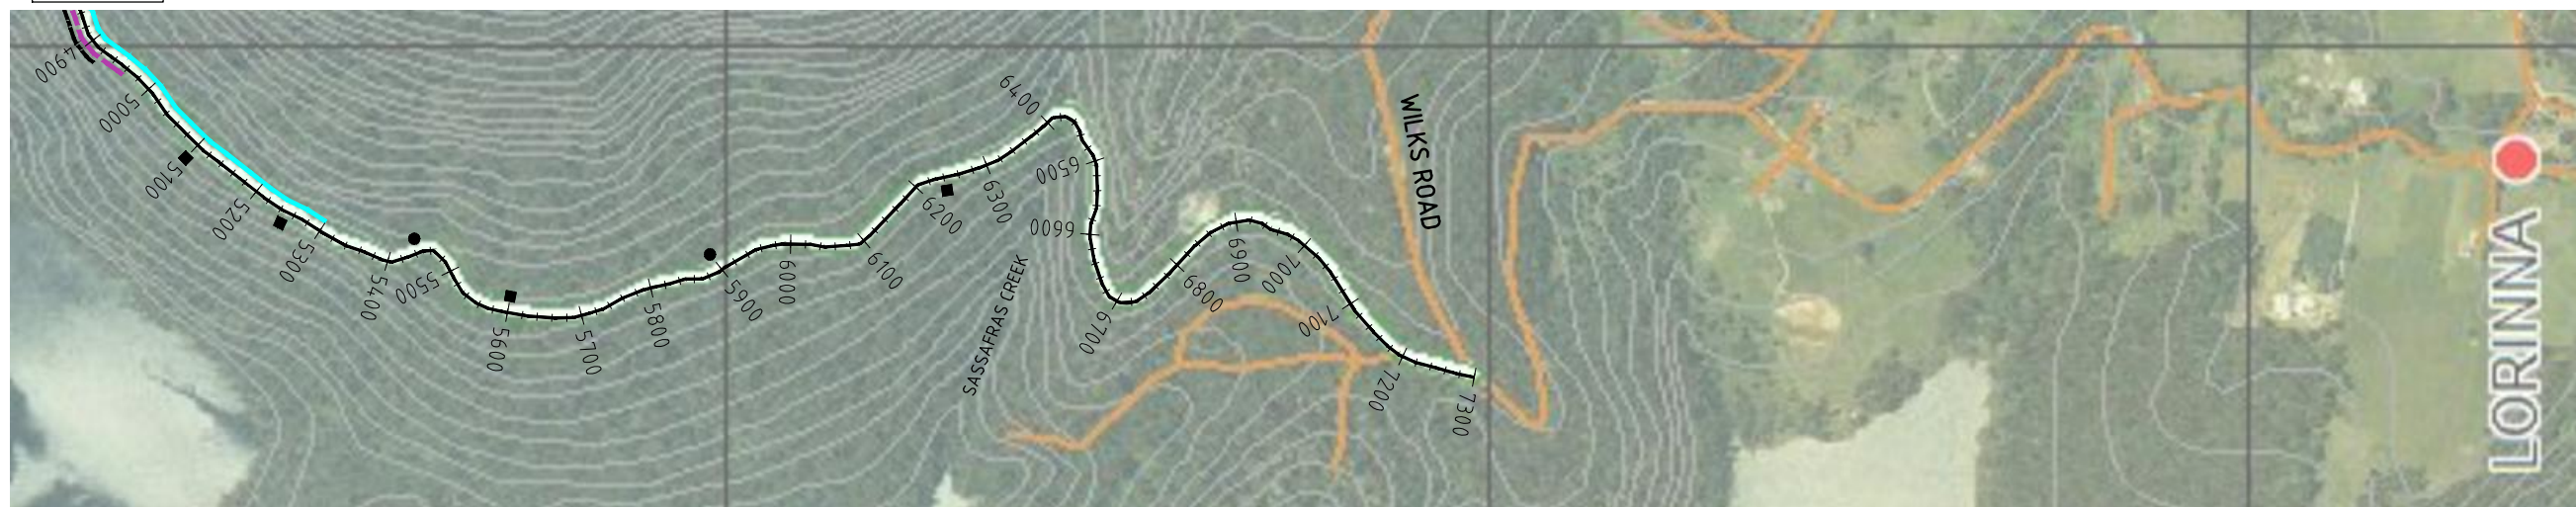
**pitt&sherry** recommends that the installation of safety barrier be based on judgement in accordance with the Austrroads Guidelines. The alignment of the road, the width of the road, site distance and the location of high rock walls has been considered and it is judged that safety barrier will be needed at White Rock Corner and possibly at 5 other locations. The location of possible safety barrier is shown on site plan 2.

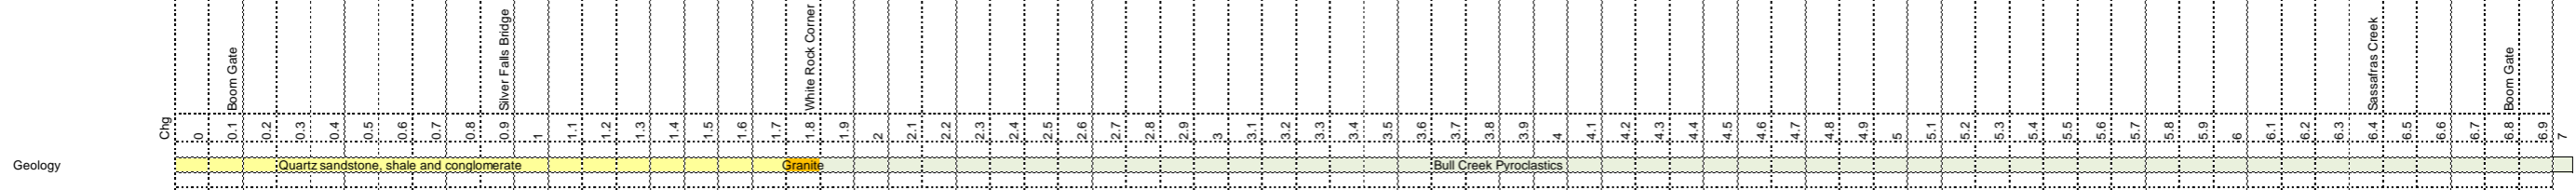
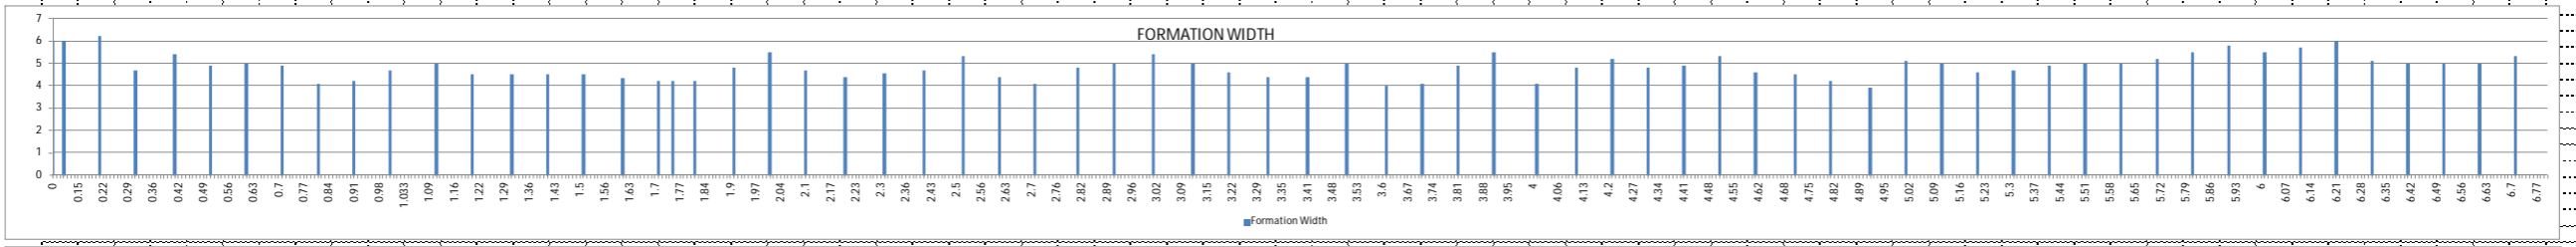
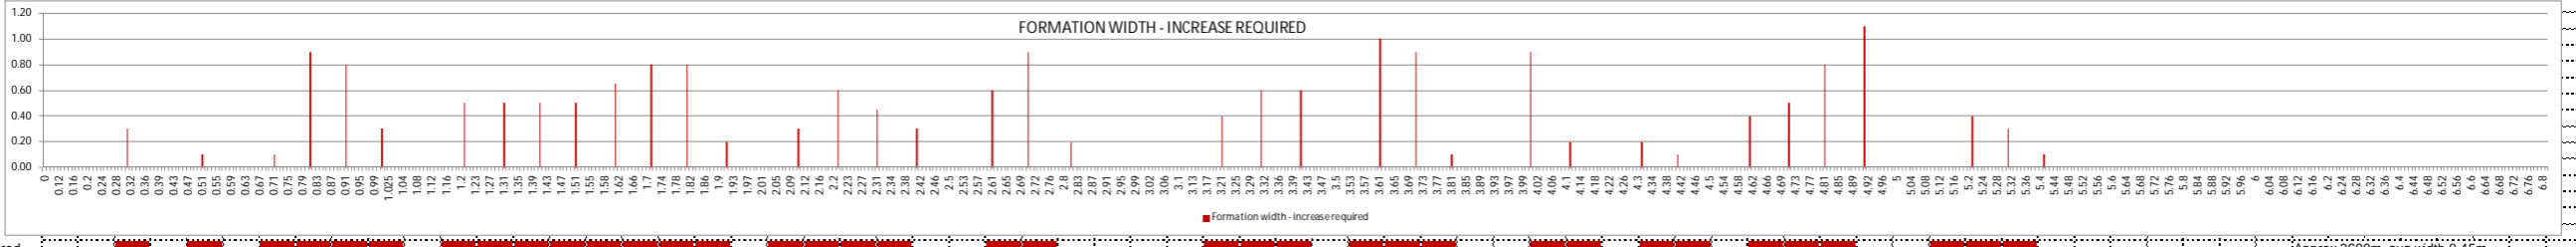
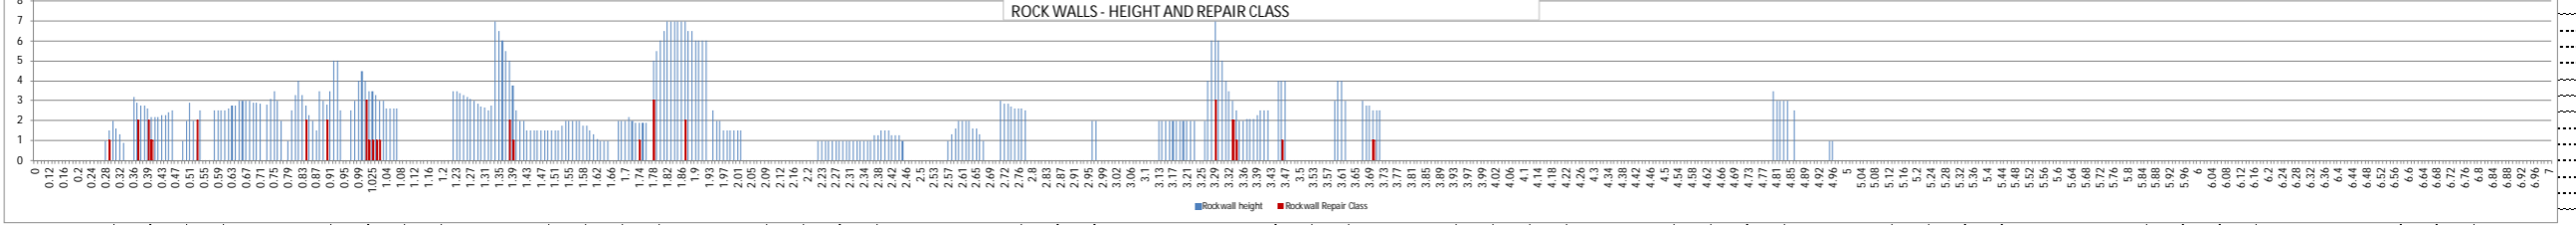
Lorinna Road Project - Road Characteristics Diagram

Inspection Date	Issues	Recommended Repairs
October 1999, p&s L99132	Chg 0.93: slip in outer western half of road	
August 2001: p&s D01041		
Kentish Council Road Closure Inspection		
2009: Kentish Road Closure	Chg 0.914: major wall failure in Oct 99 Chg 1.019: worsening wall failure detected, number of sections showing significant bulging and ablowout.	
General Inspections - Recommended Rep:		
July 1996, p&s D6007	Chg 0.39: Drainage issue. repair wall 5m. Chg 0.84: Drainage issue. Underpin wall 3m. Chg 1.36: Underpin wall 8m. Chg 1.57: Bulge in wall. Grout. Chg 2.74: wall damaged by falling log. Repair wall over 6m. Chg 3.34: Logret wall failing. Rebuild wall 10m. Chg 4.8: Drainage issue. Rebuild top of wall 10m.	
June 2002, p&s D02016.	Chg 0.37 Chg 0.57: Gabion Wall 4m Chg 1.02: Gabion wall 10m Chg 1.38: Gabion Wall 14m Chg 1.78 - White Rock Corner. Rebuild wall 60m2 Chg 4.0: Gabion wall 30m	
Nov 2008, p&s LN08177	Chg 0.37 & 0.39: MED PRIORITY. Gabion Wall 5m Chg 0.53: MED PRIORITY. Repair Chg 0.84: MED PRIORITY. Underpin wall 3m. Chg 1.01: HIGH PRIORITY. Gabion wall 8m Chg 1.38: MED PRIORITY. Underpin wall 8m Chg 1.78 - White Rock Corner. HIGH PRIORITY. Gabion Wall 60m2 Chg 3.3: HIGH PRIORITY. Repair wall 15m Numerous low priority sites identified but have not been included here
